# Manhole Inspection Summary

Manhole # S27G\_\_026MH

Insp Date: **6/21/08 1:39 PM**

**Location** Address: **927 Namity**

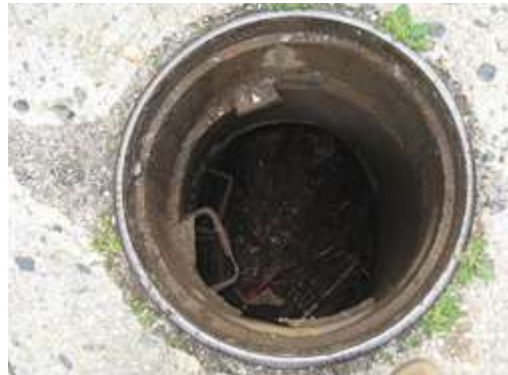
Top View

debris

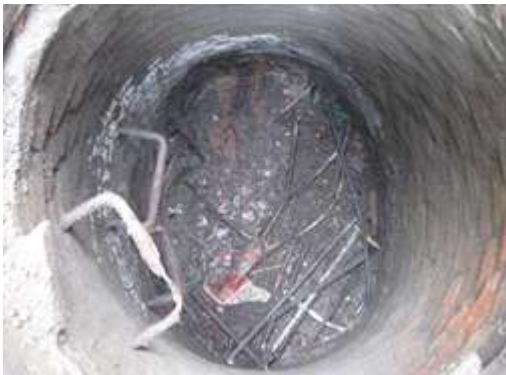
Additional Top View

Manhole is full of debris

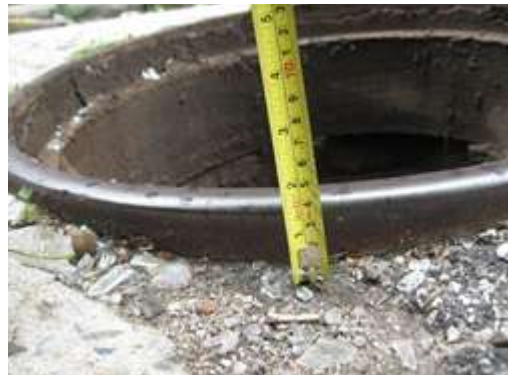
a/b grade

1.75 inch offset, leaks

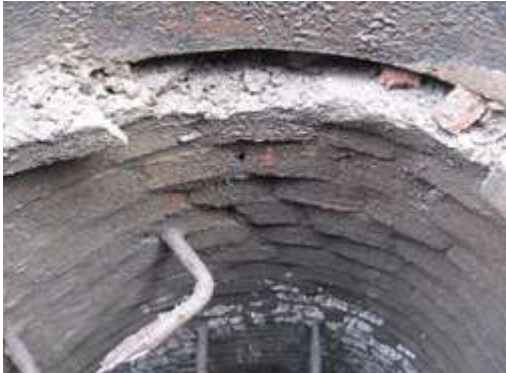
Defect 2

chimney cond deteriorated, chimney moartar, chimney flow wall, corbel flow wall

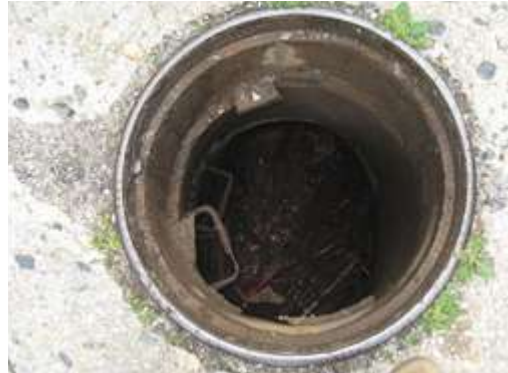
Defect 3

bench and channel debris

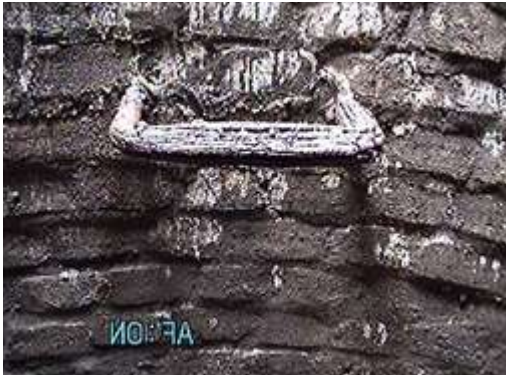
Defect 1

corroded steps

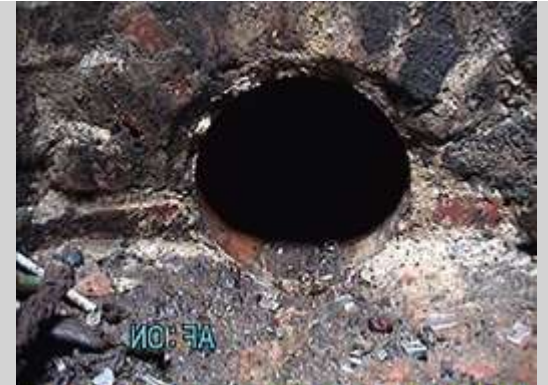
12 O'Clock Outflow

Deposits: ☐ None ☐ Mud ☐ Sludge ☒ **Debris** ☐ Grease

Silt Depth: **0.2** (in.) Deposits Extent: **Light**
